## COMPARATIVE RISK ANALYSIS

Commissioned by  
**Concrete Europe &  
BIBM - Federation of the European  
Precast Concrete Industry**

**Augustas Risk Services**

September 2026

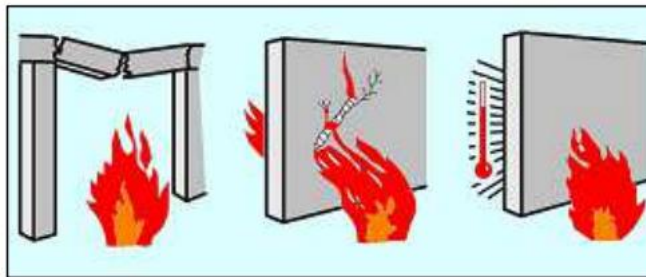
- EN 13501-1 regulates materials reaction to fire.
- EN 13501-2 concerns the fire resistance of construction elements, expressed in terms of load-bearing capacity (R), integrity (E), and thermal insulation (I), for predefined durations (30, 60, 90, 120 minutes and beyond).

Fig. 2, Loss of load-bearing capacity (R), loss of integrity (E) and loss of insulation (I)

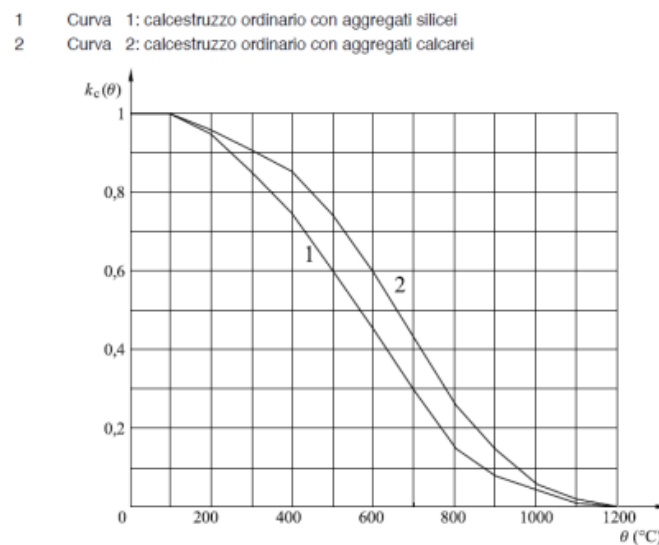
Numerous experimental studies have shown that the compressive strength of concrete decreases as a function of the temperature reached, with a gradual trend well documented in the literature and expressed through the reduction factor  $k_c(\theta)$ , yielding:  $f_{ck}(\theta) = k_c(\theta) \cdot f_{ck}(^{\circ}\text{C})$ . In particular, up to approximately 300 - 400 °C, the loss of strength is generally limited, whereas more significant reductions occur at higher temperatures, coinciding with the decomposition of cement hydration products and the increase in internal microcracking (CEB, *Bulletin 208*, 1991; FIB, *Model Code 2010*).

Fig. 3, Trend of the coeff.  $k_c(\theta)$  as a function of temperature  $\theta$  (EN 1992-1-2:2005)

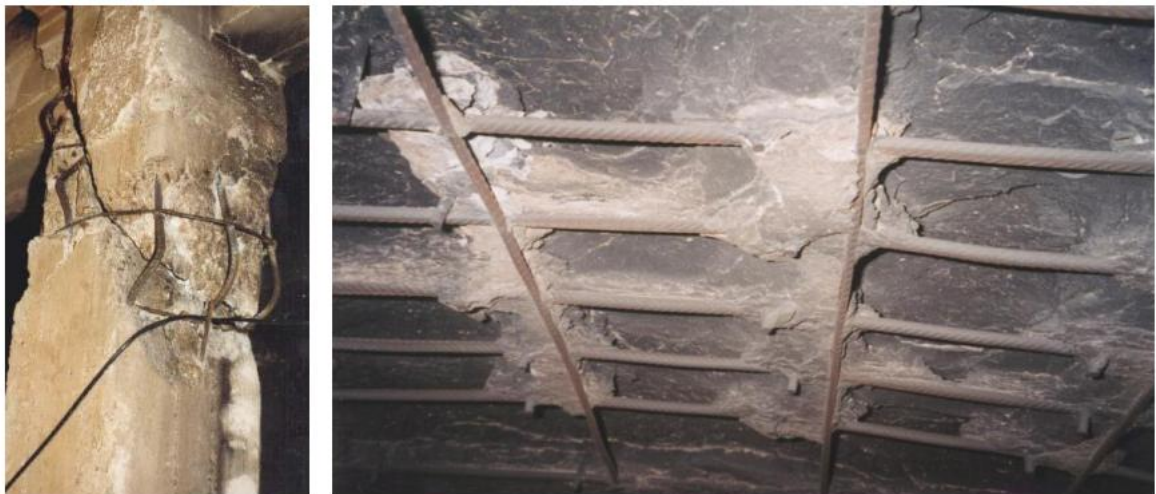
Modern fire-design practice for reinforced concrete includes specific mitigation measures aimed at reducing the probability of critical phenomena under fire conditions. These include the correct design of concrete cover, calibrated according to the required fire-resistance class, the selection of concretes with controlled composition and adequate permeability, and the use of polypropylene fibers, widely documented in the literature as an effective solution to facilitate vapour pressure dissipation within the cementitious matrix during heating (*FIB, Bulletin 38, 2007; Hertz, 2003*).

*Fig. 4, Some effects of spalling (Innocenzo Mastronardi)*

Spalling therefore represents a potentially critical but manageable phenomenon, whose occurrence depends on well-identified and extensively studied variables. Its proper consideration during design and safety assessment makes it possible to avoid excessively conservative interpretations while recognising, at the same time, the ability of concrete to provide reliable structural performance even under severe fire conditions.

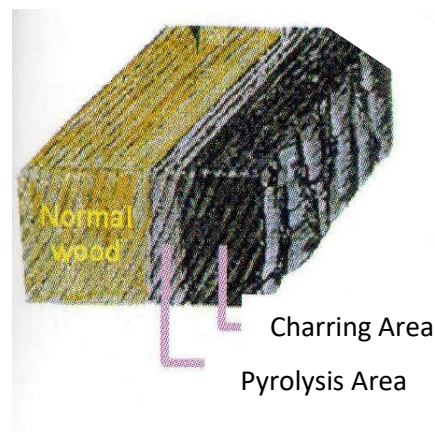
Charring represents the macroscopic outcome of these processes, whereby the outer layer of the timber is converted into char, a brittle and non-load-bearing material with significantly lower thermal conductivity than virgin wood. Although this char layer can slow heat transfer into the element, its formation is a direct consequence of combustion and therefore corresponds to an irreversible loss of mass and load-bearing cross-section (*Buchanan & Abu, 2017*).

Fig. 5, Charring on a wood sample

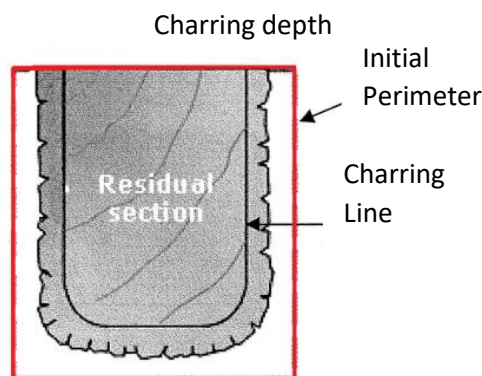
The standard provides nominal charring rates ( $\beta_0$ ), differentiated according to the type of timber product (solid timber, glued laminated timber, CLT panels) and the fire-exposure conditions. Typical nominal charring rates range between 0.7 and 0.9 mm/min, while the mechanical properties of the uncharred core remain essentially unaffected by elevated temperatures. These values are consistent with measurements under standard exposure, where 0.67 mm/min was recorded over the first 10 mm of GLT columns tested under the ISO 834 curve. Under natural fire exposure, the same sections showed rates between 1.52 and 2.00 mm/min over the first 10 mm across all seven compartment tests, two to three times the standard value, decreasing progressively towards the decay phase (*Robert et al., 2023*). To these nominal values the standard adds an additional thickness, the zero-strength layer, representing material that, although not fully charred, is considered unable to contribute to the load-bearing capacity (EN 1995-1-2). It is not a physical boundary observed in tests but a design allowance, calibrated so that the verification remains on the safe side across the range of conditions covered by the standard.

Fig. 6, Charring behaviour and Effective Cross Section

The simplified design approach treats the problem as a geometric reduction of the load-bearing cross-section, allowing the use of calculation methods analogous to those applied at ambient temperature. The idealisations on which it rests, a uniform char front and a constant charring rate (*Buchanan & Abu, 2017*), are deliberate. Timber is a natural material whose density, moisture content and defect distribution vary within a single species and within a single element, and the standard responds to this variability by adopting nominal values calibrated on the upper range of observed behaviour, so that the design outcome remains conservative without requiring a case-by-case reconstruction of the charring process. The model is therefore a safe design method rather than a predictive description of a specific element in a specific fire, and the same distinction applies to the simplified provisions of EN 1992-1-2.

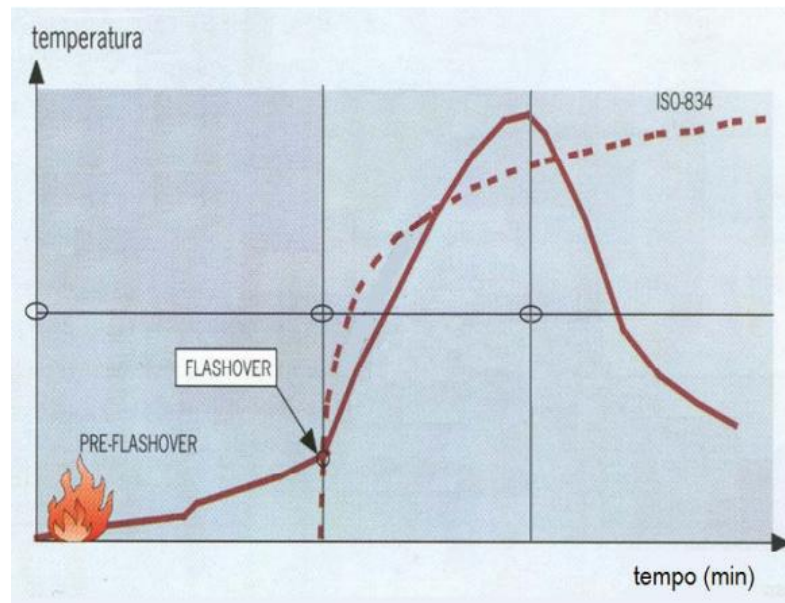
A substantial body of experimental research has shown that the charring rate can vary as a function of parameters not explicitly accounted for in simplified design models, such as fire intensity, compartment ventilation, multi sided exposure, and the presence of construction discontinuities (SFPE, 2016). In particular, under non standardised real fire scenarios, the incident heat flux may differ significantly from that associated with the ISO 834 curve, thereby influencing the development of charring.

Fig. 7, Natural fire curves compared with the ISO 834 standard fire curve (Ing. G. Biffarella, 2014)

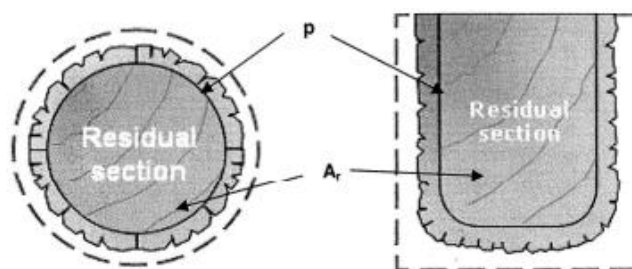
From a quantitative standpoint, the load-bearing capacity of an element with a uniform cross-section depends non-linearly on its geometric dimensions. For rectangular sections in bending, for example, the elastic section modulus is proportional to the product of the width and the square of the height ( $b \times h^2$ ). Consequently, even a modest reduction in dimensions due to charring can lead to a substantial decrease in capacity. As an illustrative example, for a rectangular timber member exposed to fire on three sides, a 10% reduction in both width and height (initial dimensions normalised to 1; reduced to  $0.9 \times 0.9^2$ ) results in an approximate 30% reduction of the section modulus, while a 15% reduction leads to a decrease of around 40%. Whether this reduction exhausts the margin available at the ultimate limit state depends on the utilisation ratio of the element in the fire design situation. The relationship is illustrative rather than generally applicable, since the actual loss depends on the governing failure mechanism, whether bending, compression, tension, shear or stability, on the cross-sectional geometry and on the loading conditions. In a five-layer vertical CLT panel, for instance, a 40% reduction in thickness corresponding to the loss of two layers reduces the radius of gyration and increases slenderness, so that capacity becomes governed by stability rather than by strength, particularly under eccentric vertical loads. These examples illustrate the sensitivity of residual capacity to the reduction of the effective cross-section.

Fig. 8, Examples of Residual Cross-Sections for Circular and Rectangular Sample

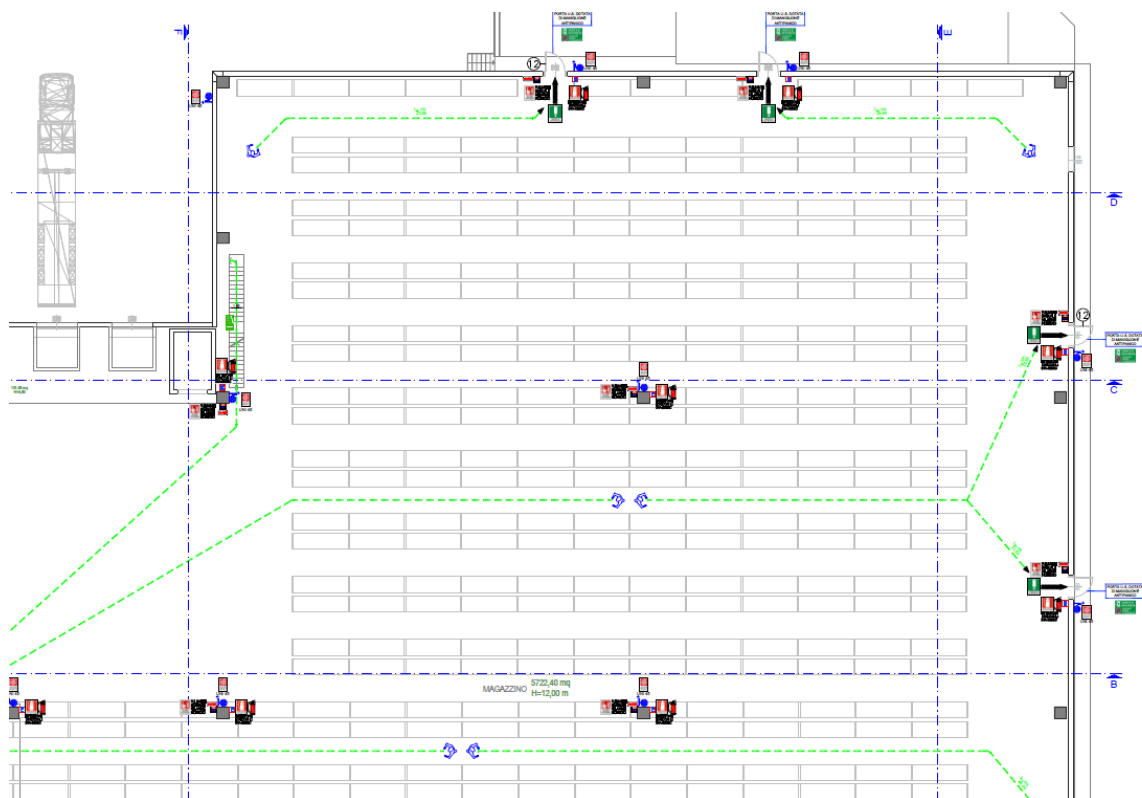
Overall, the facility represents a high-value industrial asset characterized by significant combustible storage concentration, advanced operational logistics, and a structurally robust reinforced concrete load-bearing system designed to ensure fire resistance, compartmentalization, and structural stability under fire exposure.

Fig. 9, Detail of the automated warehouse plant

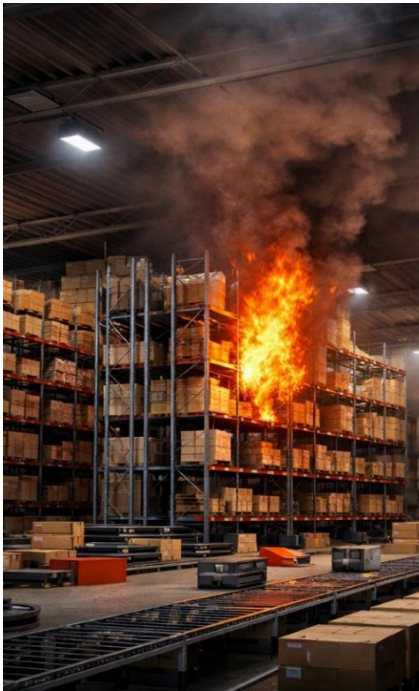
The fire develops following a fast growth rate, typical of rack storage configurations. Vertical flame spread is accelerated by the chimney effect within storage aisles, rapidly involving multiple pallet levels. As hot gases accumulate beneath the roof, flashover conditions are reached within the initial fire sector. Radiative heat transfer promotes horizontal spread across adjacent rack arrays. Given the absence of effective compartmentation capable of halting propagation at an early stage, the fire progressively involves a substantial portion of the storage area.

*Fig. 10, Simulated image of an early stage of the fire under MFL conditions*

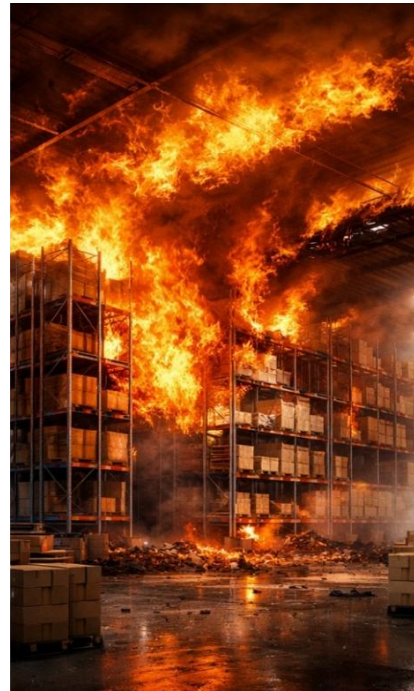
*Fig. 11, Simulated image of a fully developed fire through the racks*

Peak heat release rates may reach several tens of megawatts before structural degradation or fuel depletion begin to limit further escalation. Gas layer temperatures in the upper zone are expected to approach 900-1000°C, with sustained high thermal exposure lasting well beyond one hour. The fire continues to propagate until it encounters either areas devoid of combustible storage or structural boundaries capable of resisting full penetration.

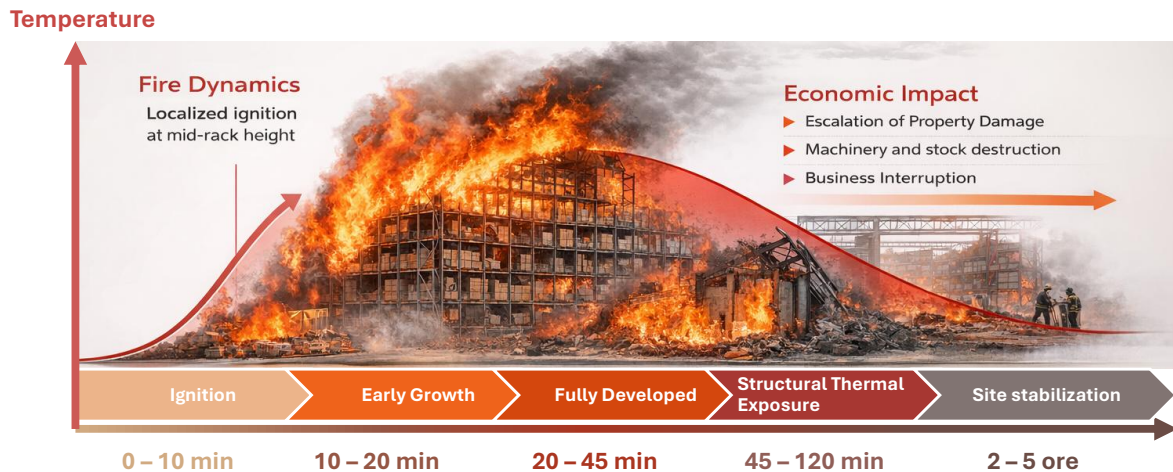
study, parts of the enclosure system, specifically the roof structure and portions of the wall assemblies, are assumed to be realised using engineered timber elements. Under prolonged fire exposure and in the absence of effective suppression, these elements may progressively become involved in the fire.

Unlike reinforced concrete, timber is a combustible material and may contribute to the fire load once its protective layers are compromised or when it is directly exposed to flames. As the fire continues to develop within the storage compartment, the high temperatures reached in the upper smoke layer progressively affect the timber roof elements.

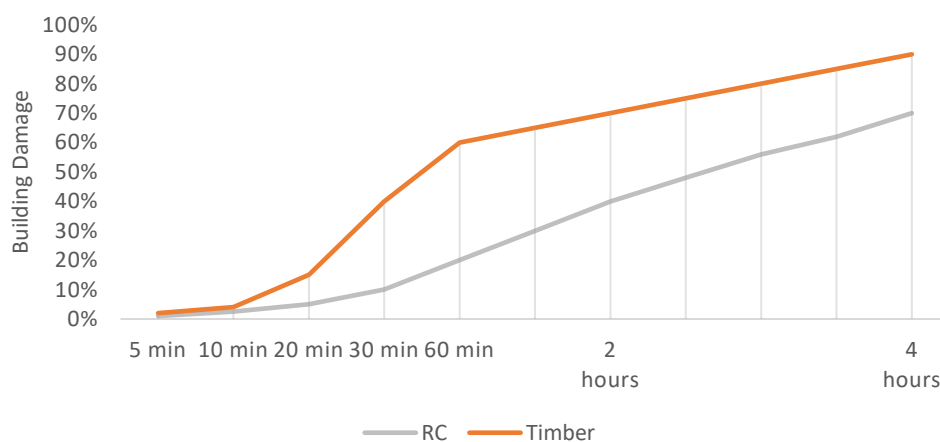
So, this first comparison highlights how the intrinsic non-combustibility and thermal stability of reinforced concrete contribute to maintaining structural integrity even under extreme fire conditions. Conversely, when combustible structural materials are involved, the fire may progressively affect the structural system itself, increasing the extent of damage and the complexity of post-fire recovery operations.

Graph 1, Building Damage comparison between RC and Timber under MFL scenario

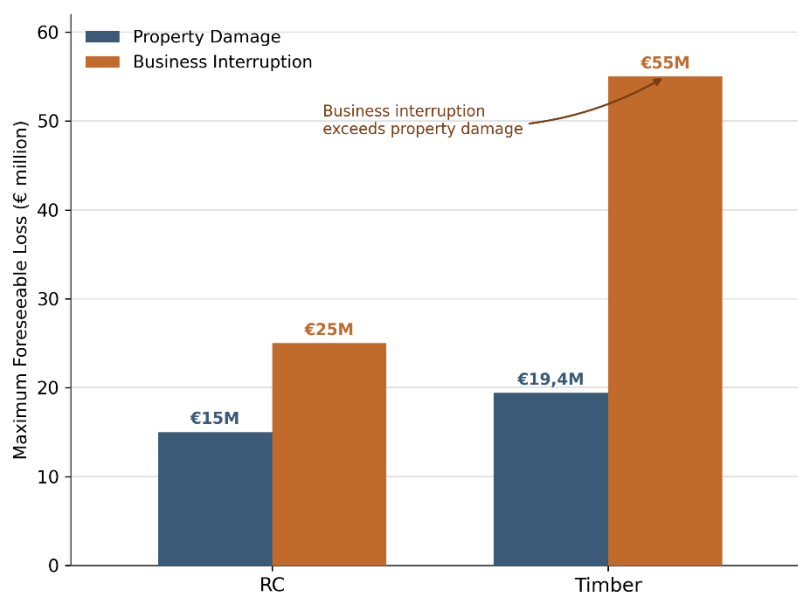
Graph 2, Property Damage and Business Interruption under the MFL scenario, Case Study #1

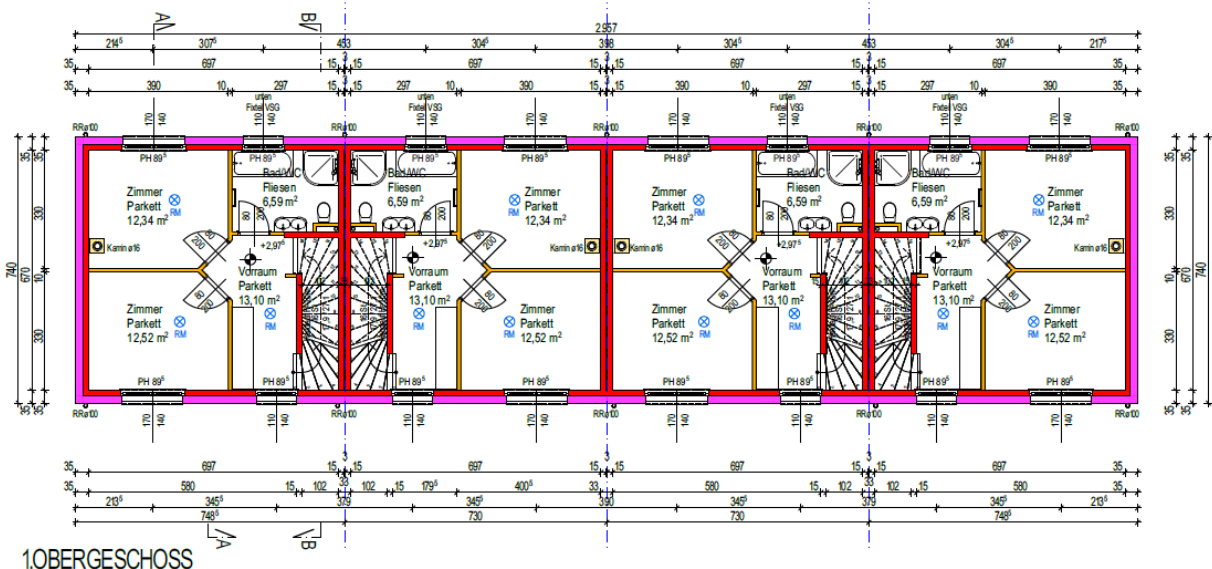
From a fire engineering perspective, the structural system is predominantly non-combustible, with the exception of the roof assembly. This configuration provides a robust compartmentation framework, limiting fire spread and ensuring structural stability even under severe fire exposure

Fig. 13, Detail of the first floor

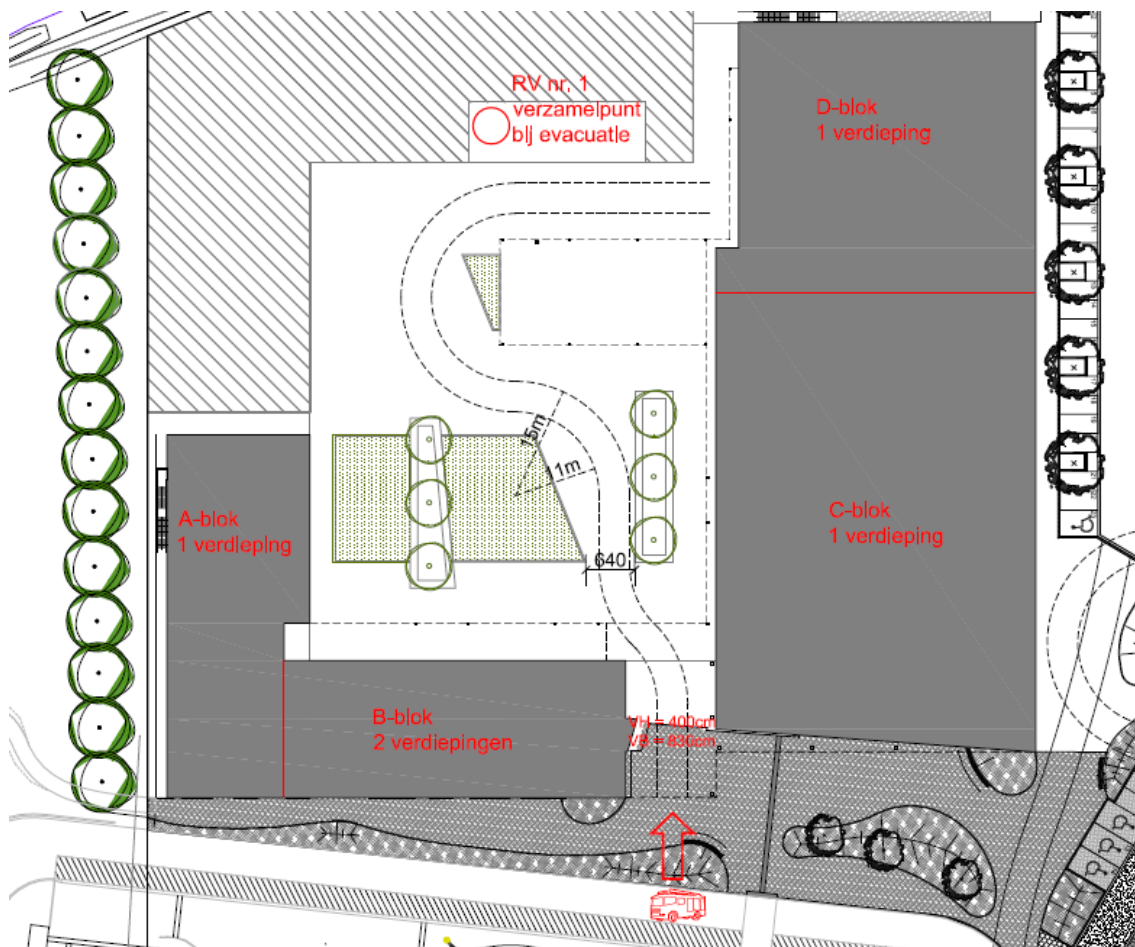
A distinctive feature of this facility is the presence of special technical risks typically associated with technical education: a dedicated welding centre at the ground floor of block C, equipped with welding booths, local fume-extraction systems and a fixed gas-distribution network supplied from a separate gas room and an external gas-cylinder store; wood-dust extraction systems serving the machine park of the wood workshops (blocks C and D); and a compressed-air distribution network. These installations, fully documented in the as-built MEP drawings, represent both credible ignition sources and factors capable of influencing fire development in severe scenarios.

From a fire protection perspective, the building is equipped with a complete automatic fire-detection system, optical and ionization smoke detectors throughout, supplemented by gas detectors with local warning lamps in the workshop and gas areas, manual call points behind break-glass, alarm sounders and a fire-brigade interface. First-intervention means consist of wall-mounted fire-hose reels housed in fire-rated niches and ABC portable extinguishers; natural smoke-vent hatches are provided. In line with common European practice for school buildings, no automatic sprinkler protection is installed. The local fire brigade response time is about 8 minutes, a parameter that plays a central role in the Normal Loss Expectancy scenarios developed below. The building's fire-safety concept therefore relies on the combination of early detection, rapid external intervention, and a robust passive compartmentation strategy.

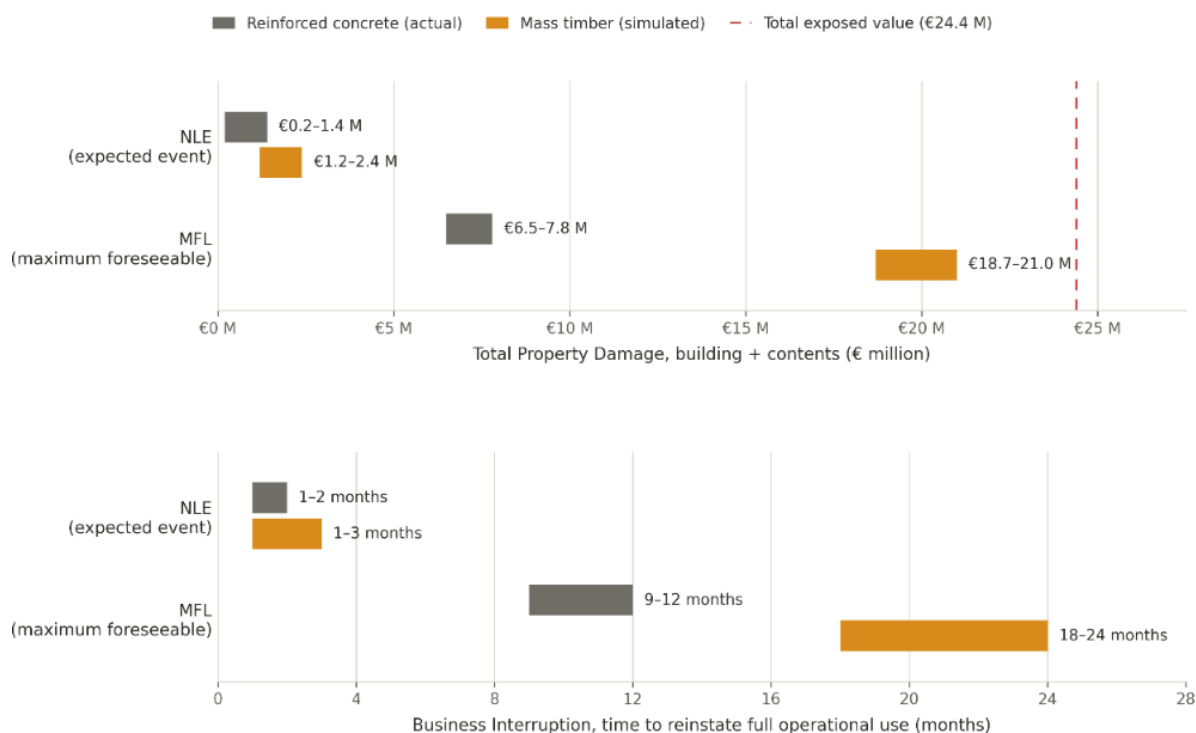
The second mechanism concerns compartmentation. In the existing building, the critical compartment boundary consists of a 140 mm full-height precast concrete fire wall, an inherently non-combustible barrier whose performance does not depend on applied protection systems or maintenance-sensitive components. In the timber alternative, the corresponding boundary is formed by an encapsulated CLT wall whose fire-separating function remains dependent on the integrity of the protective linings and which itself becomes combustible after their failure. Consequently, the fire that remains confined within a single 1,588 m<sup>2</sup> compartment in the reinforced concrete building propagates throughout the entire workshop wing in the timber solution, leading to collapse of the fire-exposed structural elements, residual structural vulnerability during the cooling phase, and the subsequent demolition of the affected portion of the building.

Graph 3, Ranges from the MFL and NLE scenarios (Case Study #4), applied to the provisional building replacement value of €20M and to the insured contents value of €4.4 M. Durations and percentages exclude temporary relocation costs

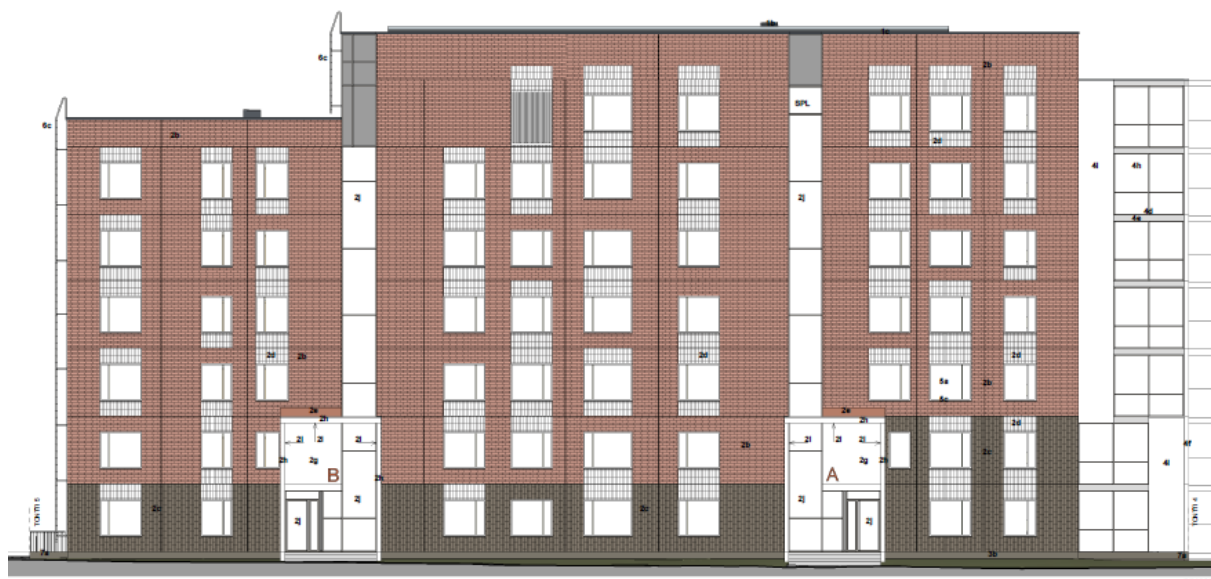
The building comprises eight storeys and a basement, with a total height of 23.2 m above ground and a gross floor area of 4,340 m<sup>2</sup>. Two staircases, each served by a lift, divide the building into two sections of seven and six residential floors respectively, for a total of 52 apartments. The basement accommodates the common facilities, a club room, sauna and laundry rooms, technical rooms and the tenant storage rooms, part of which are located within the S1-class civil defence shelter, while pram and equipment stores are located at entrance level. Car parking is provided in a separate facility outside the building, so that no vehicle fire load is present within the premises. The apartments are provided with glazed balconies on the main facades.

About the fire compartmentation strategy, each apartment constitutes an independent EI 60 compartment, the basement is separated at EI 60, the tenant storage rooms are enclosed at EI 90, the balconies are separated at EI 30 and the staircase service enclosures at EI 30. The design fire load is standard throughout the building, rising above the standard only in the tenant storage rooms, where the load-bearing structures are correspondingly rated R 120 against the general requirement of R 60. Service penetrations through the compartment boundaries are sealed with certified fire-stopping systems rated EI 60 to EI 120.

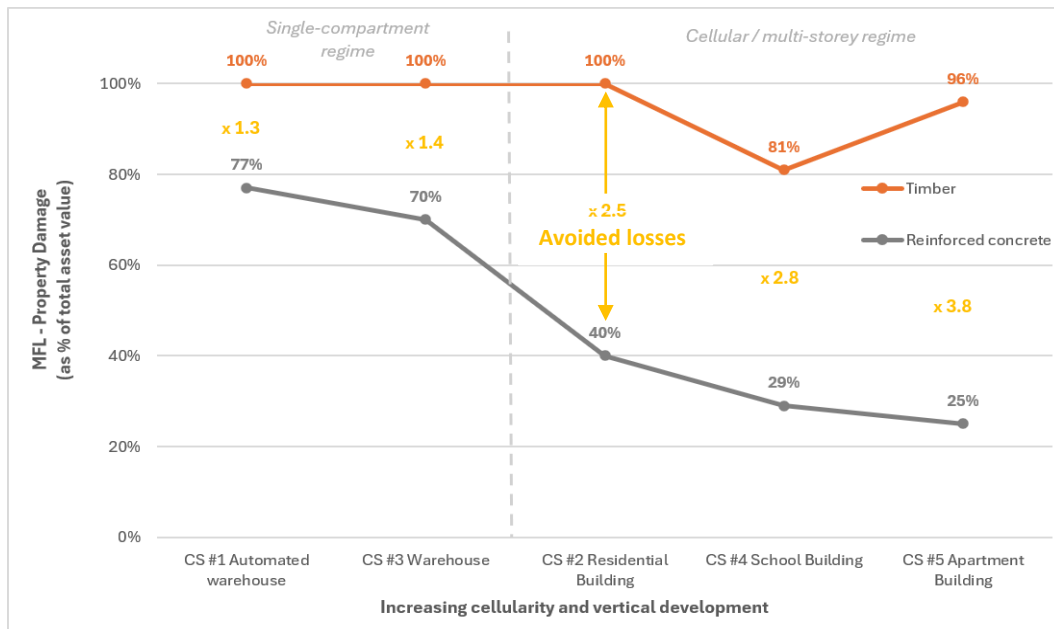
The ratio between the two structural solutions is lowest in large open industrial buildings, where the fire develops within a single compartment and the dominant fuel is the stored commodity rather than the structure itself, so that reinforced concrete offers only a limited reduction in Property Damage and its principal advantage lies instead in structural stability and post-fire recoverability. As compartmentation becomes more effective, the difference increases markedly. Reinforced concrete preserves the integrity of the fire barriers, restricting damage to a limited portion of the building, whereas the combustible structural system progressively compromises those same barriers and allows fire to spread beyond the compartment of origin. The greatest divergence occurs in vertically developed buildings, where the floor assemblies simultaneously provide structural support and compartmentation, and their failure not only permits vertical fire spread but also creates the conditions for progressive collapse. Across the five cases the ratio of the timber loss to the reinforced concrete loss therefore rises from approximately 1.3 in the open warehouse to nearly 4 in the eight-storey apartment building, as illustrated in the graph below. The same geometry also amplifies secondary damage, as smoke and firefighting water migrate through floor junctions and service penetrations into the storeys below, prolonging drying and reinstatement works.

Graph 4, MFL: timber versus reinforced concrete across the five case studies

This finding extends beyond the individual case studies. It indicates that the advantage of a non-combustible structural system is smallest in large open industrial buildings, where compartmentation plays only a limited role, and greatest in highly compartmented and multi-storey buildings, where the structural system also defines the fire compartments. These are also the building typologies in which mass timber construction is currently expanding most rapidly, making the relationship between structural material, geometry and compartmentation particularly relevant to future fire risk assessments.
